Machinery Messages

Case History

Using ADRE® 3 to on a pressurized water

diagnose problems on reactor coolant pump

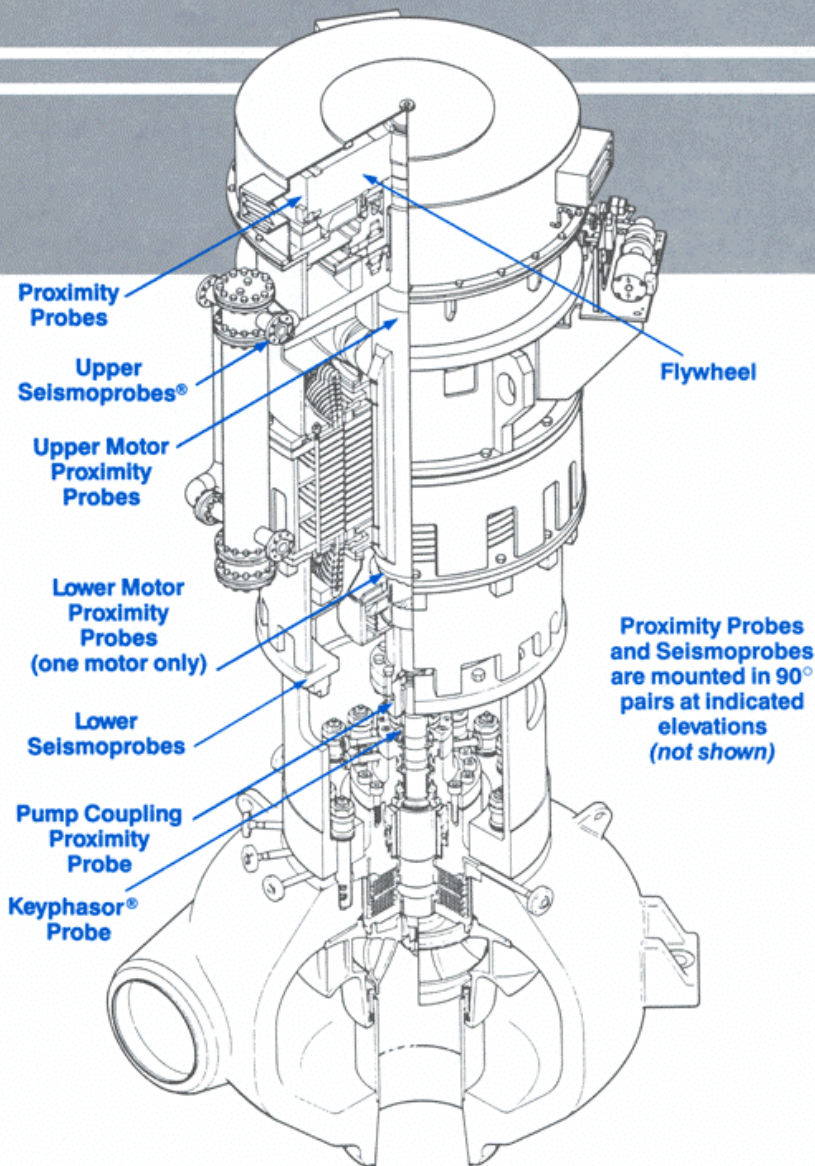
Figure 1
Diagram of a reactor coolant pump

The reactor coolant pump is a vertically oriented machine which circulates primary coolant from the pressurized water nuclear reactor through a steam generator. It is a centrifugal pump driven by a 1480 rpm, 7000 HP motor. The pump circulates approximately 94,000 gallons per minute (gpm) of coolant at 550°F (288°C) and 300 ft. (100 m) of head. The motor and pump are rigidly coupled since the entire machine has only three radial bearings (two oil lubricated, pivoted-pad motor bearings and a large water-lubricated plain journal bearing, L/D = 1). The pump bearing is maintained at a low temperature, relative to the pumped fluid, by the injection of cool water into the seal/bearing area and by the thermal barrier heat exchanger just below the bearing assembly. Coolant enters the machine from the bottom of the casing and exits through a tangential discharge. The hydraulics are designed to provide a 2000-3000 lb (907 to 1361 kg) radial side load (depending upon water temperature) on the impeller to provide a static load on the radial bearings. Figure 1 illustrates the machine arrangement.

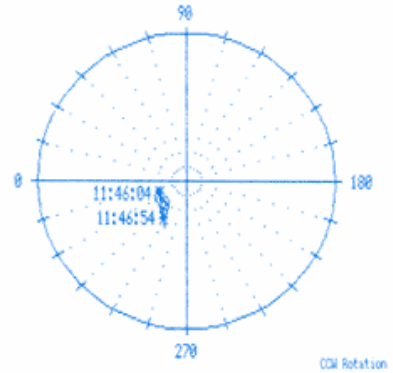
Figure 4

Machine: RCP INTERNALS CH# 1 SHAFT, HORIZ. (X)
15 JUN 88 11:46:04.3 to 15 JUN 88 11:49:04.3 Steady State 1X Filtered Uncomp

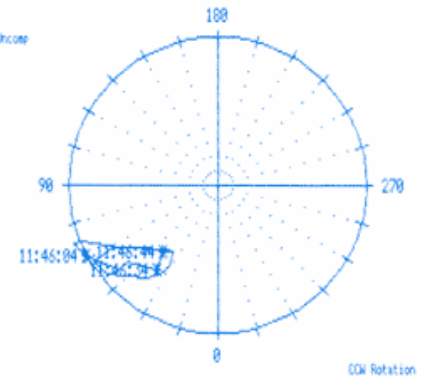
Figure 5

Machine: RCP INTERNALS CH# 2 SHAFT, VERT. (Y)
15 JUN 88 11:46:04.3 to 15 JUN 88 11:49:04.3 Steady State 1X Filtered Uncomp
